REPORT 2022

for the Restoration of the Miqvot in the rock-scarp of Mt. Zion

Restoration of the Double Miqveh in the rock-scarp of Mt. Zion
in connection with the GPIA's Mt. Zion Excavation Project

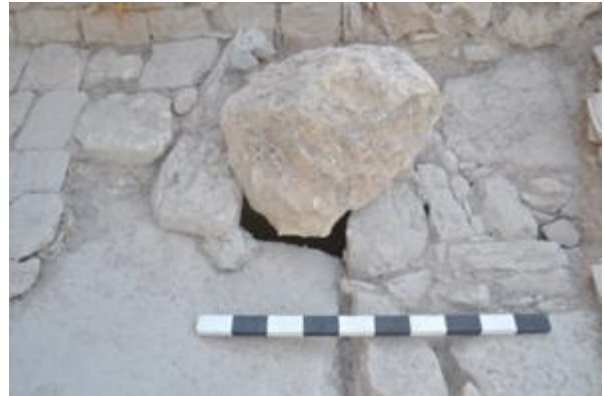
Figure 11: ground around cistern-hole (THIERRY, 2017)

The stone tiles on the ground as well as the lime mortar are loose, some parts are fully broken. The ground near the hole that leads to the cistern needs to be analyzed regarding to structural stability. Also, the stairs up to the Miqvat-level are partially broken. Without restoration, the current status risks to worsen. The ground stability is not guaranteed.

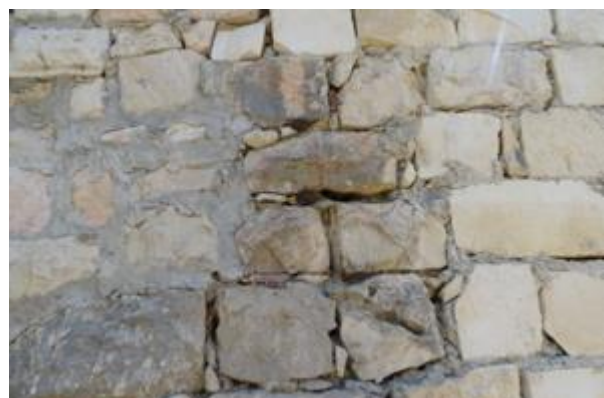
Figure 13: Loss of material in joints (THIERRY, 2017)

The jointing mortar of the walls is sandy and loose. It shows a loss of components. Because of the decay and erosion of the mortar, the stability of the stones and masonry nearby is no longer guaranteed. The use of different mortar, e.g. cement mortar in thick layers of the big cemetery wall A, contributes to the downgrade, also regarding to the aesthetic aspects.

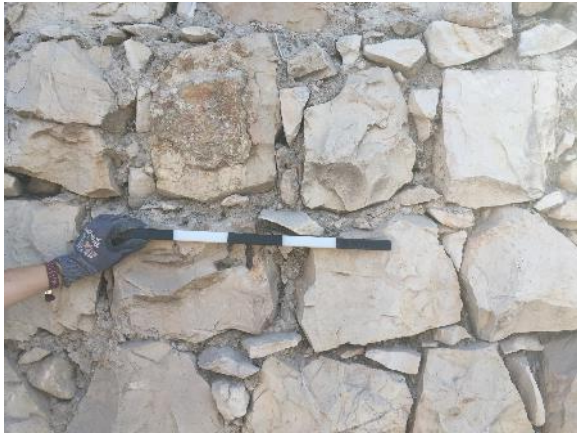
Lime mortar: In the lower part of the wall the filling mortar in the joints contains lime. Loose material, dirt and biological colonization have been scraped out 5-15 cm (in some parts up to 50 cm) with steel handles. Stable lime mortar has been left in the joints and afterwards refilled with same material (mixture listed below). Besides plants, there have also been identified snails in the joints.

Figure 33: photo documentation area 2: before measure: joint filled with lime mortar, small stones, dirt, loose material, snails and biological colonization

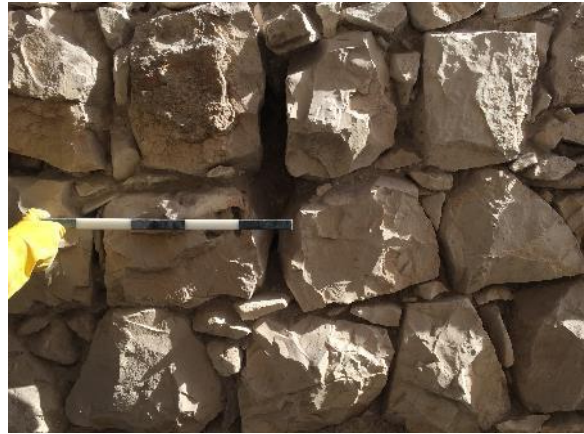
Figure 34: photo documentation area 2: joints scraped out

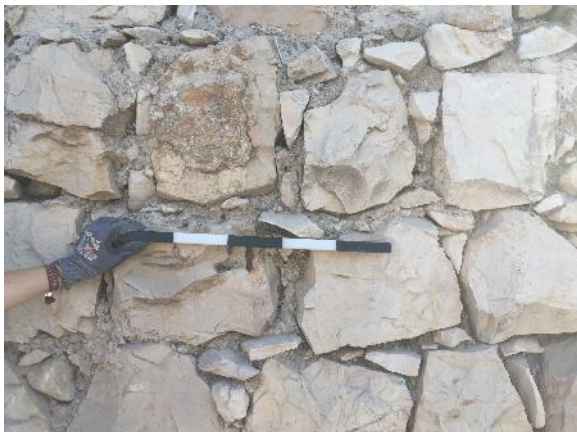
Figure 40: photo documentation area 2: before measure: joint filled with lime mortar, small stones, dirt, loose material, snails and biological colonization

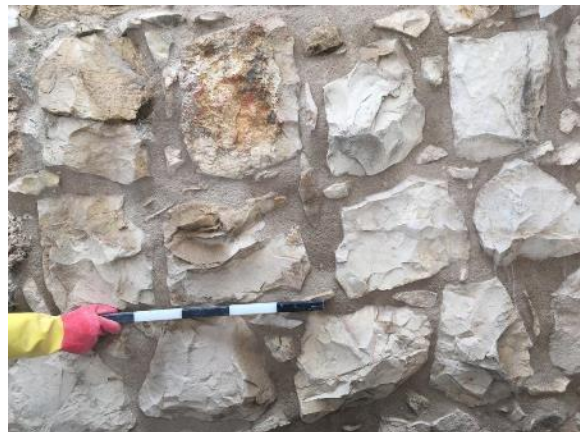
Figure 41: photo documentation area 2: final result: refilling with visible mortar after final smoothing

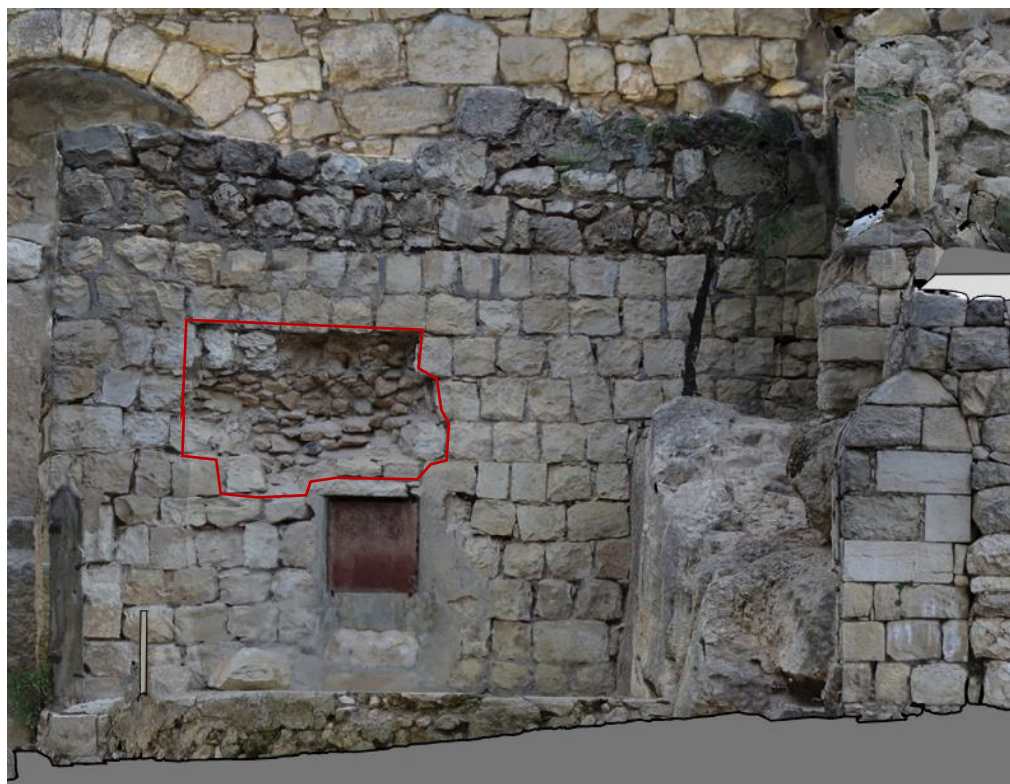
Figure 49 ortho photo, section, view south west on wall D, before measure (big missing part), E. Thierry 2016

Therefore, closing the missing parts with stones was necessary. Two qualified masons cut stones in the shape of the stones as in the wall. After cleaning and scraping out the loose material, they filled the wall with lime mortar to afterwards close the hole and masonry. The result is shown below:

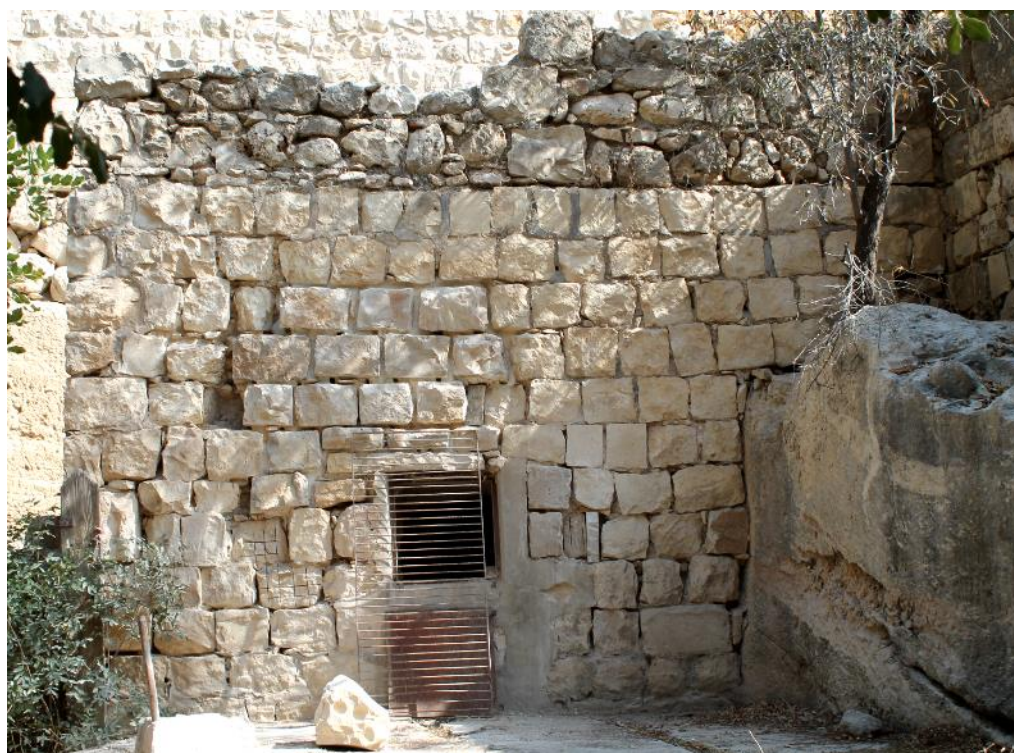
Figure 50: southeastern front of wall D after closing the big missing part, Oct. 2019

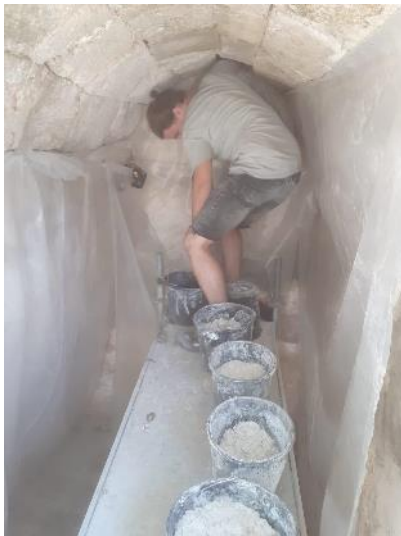
Figure 51: manually filling the hole with lime mortar, 2019

Furthermore, the vault of the northwestern Miqveh has been stabilized. The loose keystone was carefully removed. Then the approximately 1.5m deep hole was filled by hand with a mixture of lime mortar and quarry stones. After the hole behind the vault was filled, a small vault of masonry and lime mortar was built over the access hole. Before the keystone was reinstated, the vault was filled with lime mortar. Then the keystone was set into place. The stone was stabilized with a support until the mortar was dry. Finally, the mortar joints of the underside were filled to stabilize the vault completely.

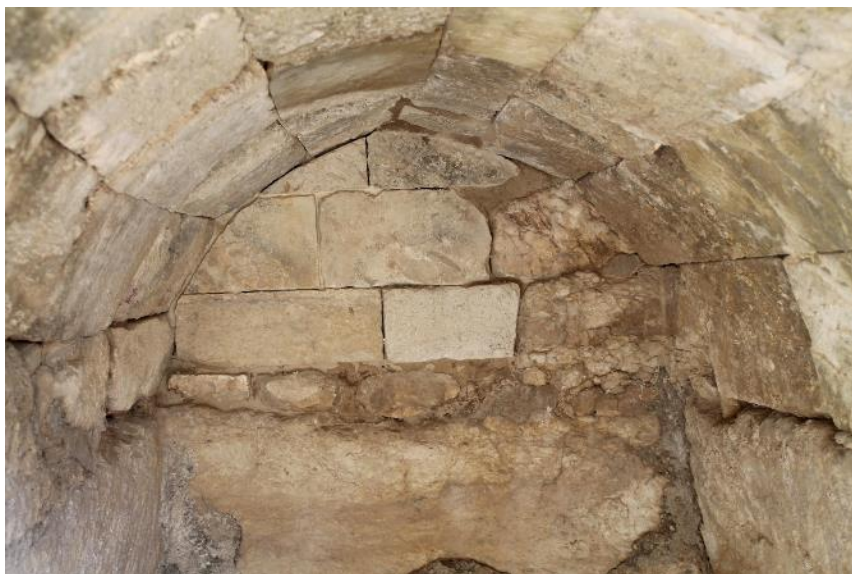
Figure 53: Final restored vault of northwestern Miqveh, 2019

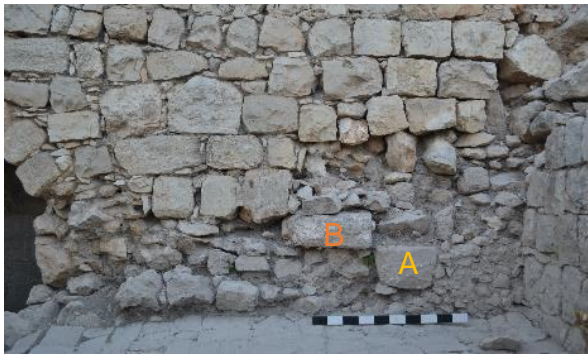
Figure 54: bottom part of big cemetery wall before measures in 2016

The campaign in 2021 included the stabilization of the big cemetery wall in the bottom parts. Therefore, the floor tiles and soil layers had to be removed up until a stable foundation level. After digging up to -80cm, a rock hewn structure had been discovered, where a new masonry could be constructed on.²³ The discoveries found in part are described in chapter 7.9.1.

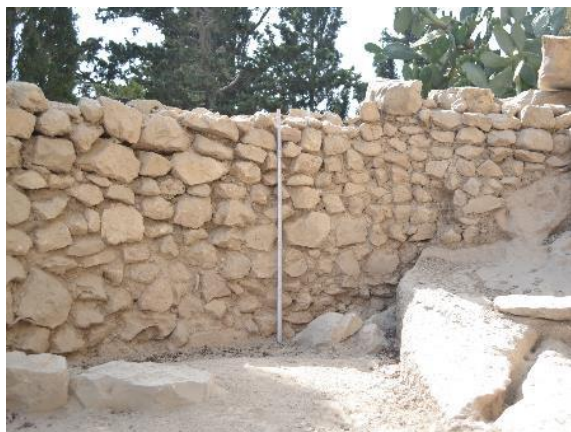
Figure 58: Wall B before measures in 2016: biological colonization, loose mortar and unstable structure, 2016

On base of the first restoration campaign, the measures included the restoration of walls B and D as well as the ground and the restoration of the plasters in the baths. All masonry has been restored as described in chapter 6.2.

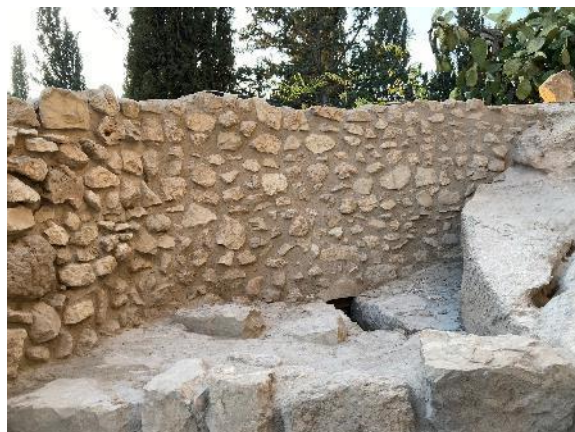
Figure 59: Wall B after measures in 2021: new mortar fillings make the wall stable and prevent new biological colonization; mural crown rebuilt for better water discharge

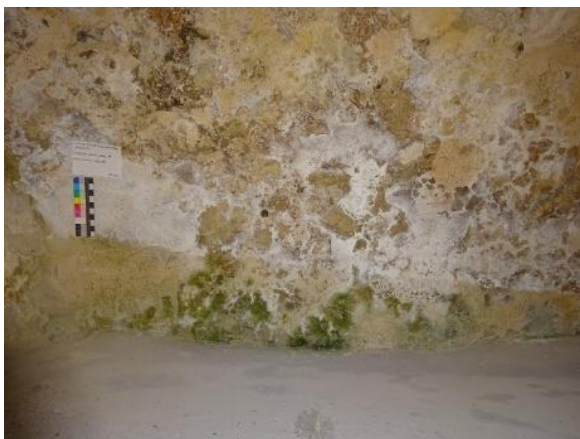
Figure 66: Veils of salt before treatment with a compress

In some areas are white veils of salt, which couldn't be removed so easily. Therefore, tests were carried out by putting compresses based on cellulose flakes. The tests showed that prolonged exposure to moisture eventually loosened the salt veils. Afterwards they were subsequently removed.

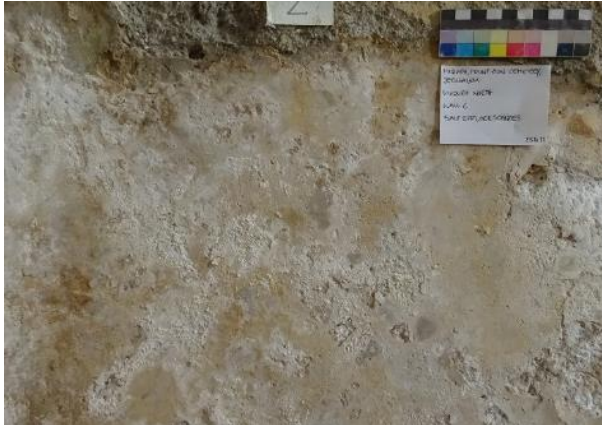
The salt efflorescence caused in many areas attrition of the plaster. To renew the strength of the plaster it was necessary to treat those areas with consolidation material. For this purpose, diluted Ludox PX30 (silica sol diluted in distilled water) was injected in the crumbling areas. Especially the grey osmanic plaster was very unsteady and needed consolidation.

Figure 68: Decay caused by salt before consolidation

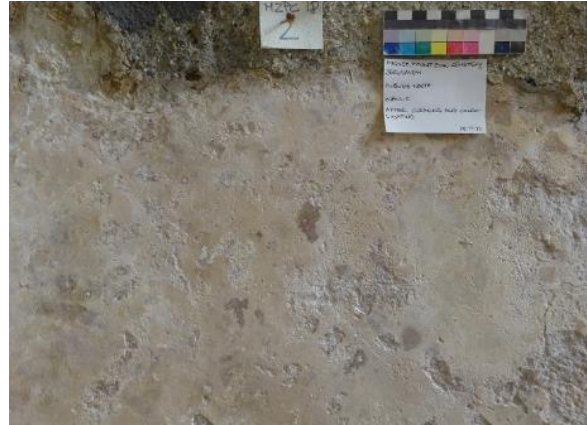
Figure 69: After removal of salt and consolidation

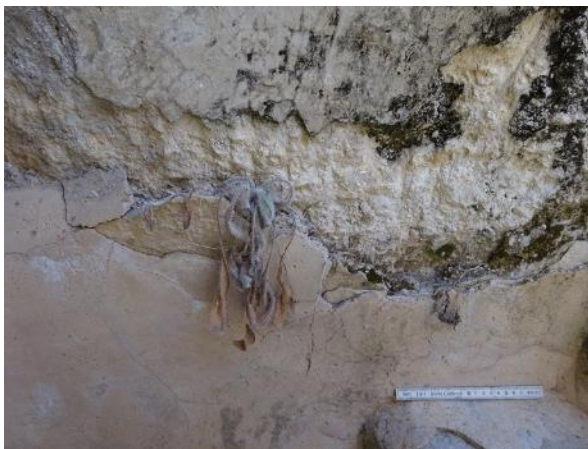
Figure 72: Previous condition of loose and hollow pieces of plaster

With this measure all hollow areas have been refilled and stabilized.

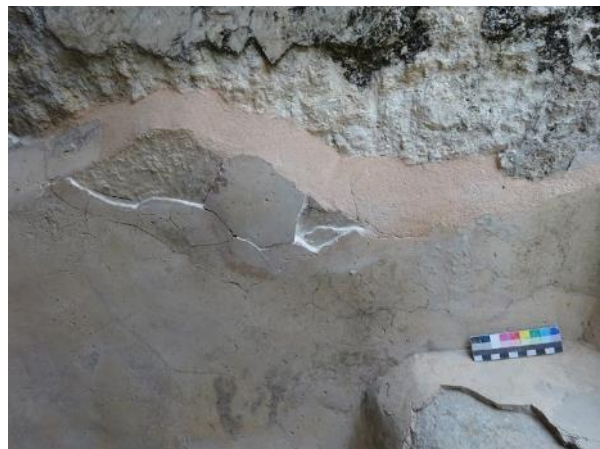
Figure 73: Condition after injections (white material) and partial pointing (orange mortar)

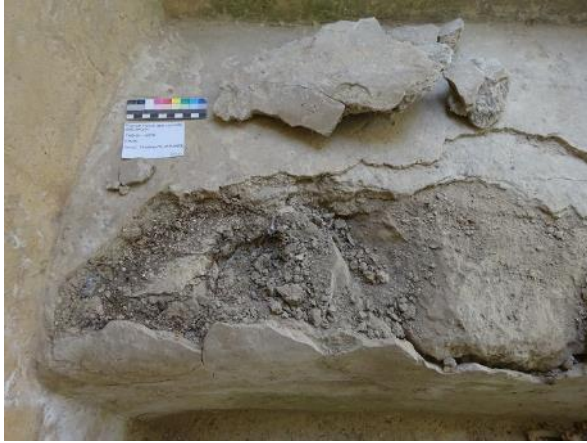
Loose pieces of plaster could be preserved. The main reason for loss of adhesion are plants which grow behind the plaster. Other pieces of plaster were fallen off due to lack of preservation works. The fragments of plaster, which had to be consolidated had to be cleaned of dirt and could be reapplied by use of injection mortar and pointing mortar.

Figure 74: Loose pieces of plaster which are removed to clean the underground

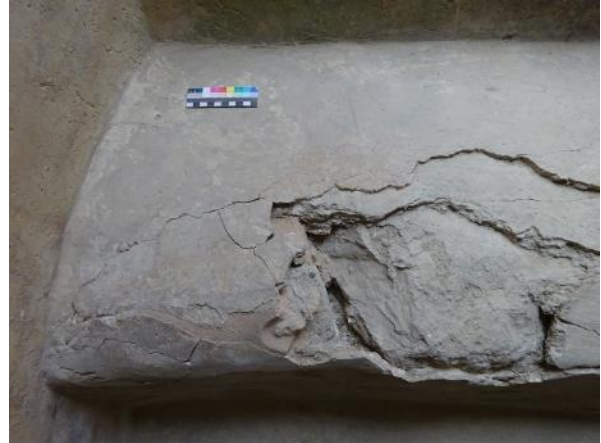
Figure 75: Reapplied pieces of plaster

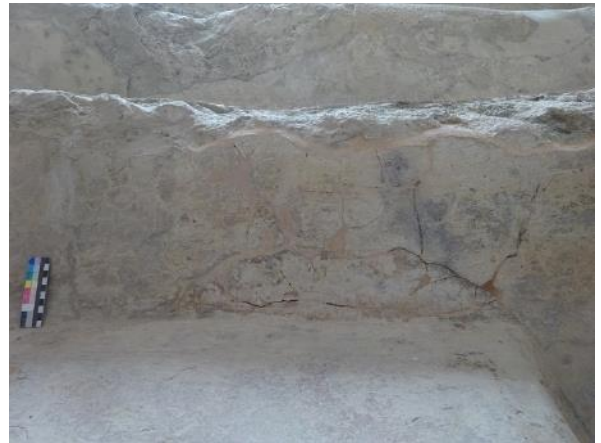
Figure 77: After reapplication of pieces of plaster

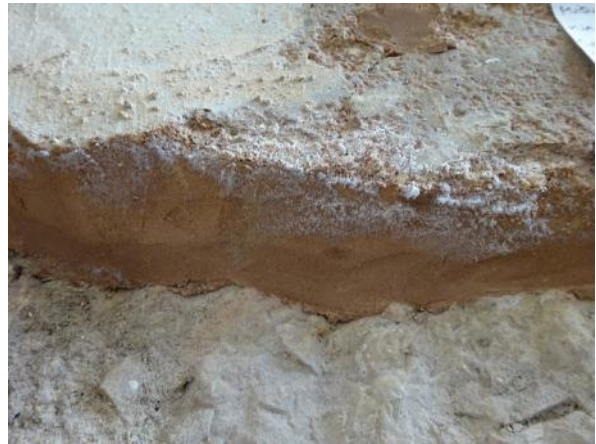
Figure 79: Picture of the new lime based pointing material

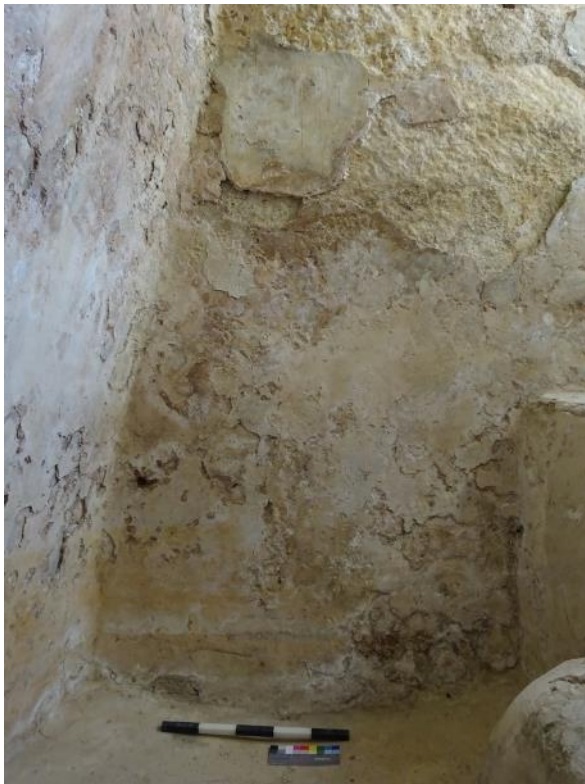
Some of the missing areas in the ancient plaster were repaired with mortar when it was necessary to stabilize the edges of the plaster and / or in areas with a lot of visible salt efflorescence.

Figure 86: Condition before removal of salt efflorescence and repairing

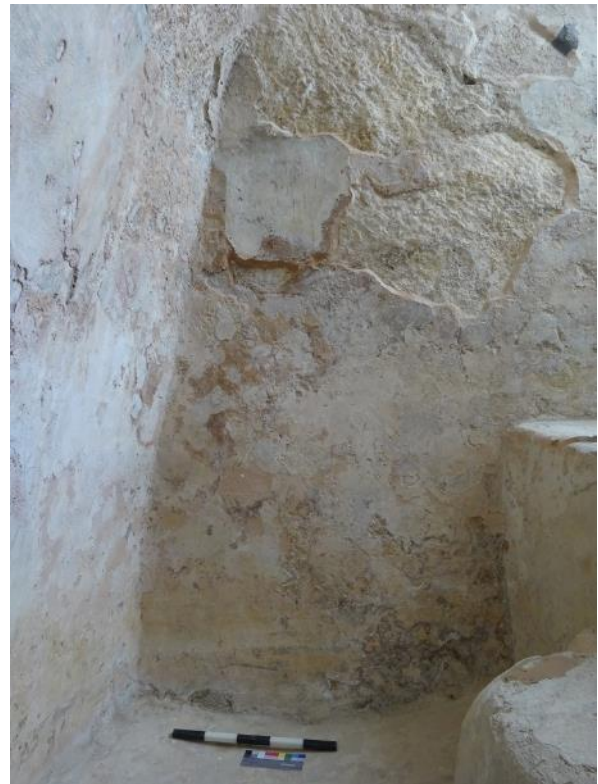
Figure 87: Condition after removal of salt efflorescence and

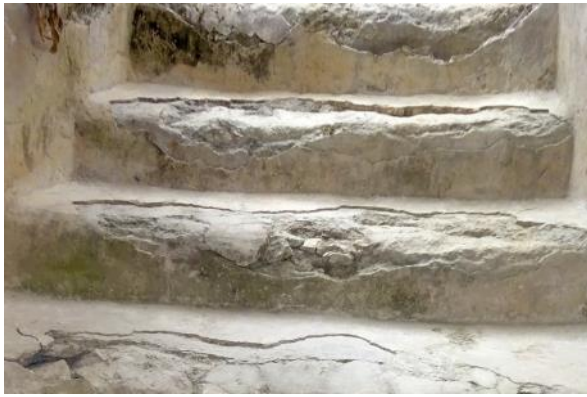
The plaster of the steps have large voids. During the restoration campaign, only emergency stabilizations could be carried out. Two types of repair mortar were used for this purpose: a gray mortar, similar to the base layer, for deep voids in the base plaster and an orange mortar for the pointing of the orange plaster. The aim of the emergency repairs was to promote water drainage and to secure endangered areas of the plaster. The measures are temporary until the restoration work can be continued.

Figure 88: Condition of the stairs after dry cleaning

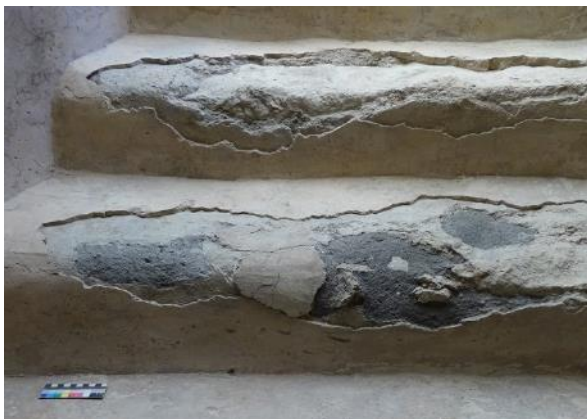
A grey repairing mortar was used for the course layer of the plaster (still wet on the picture):

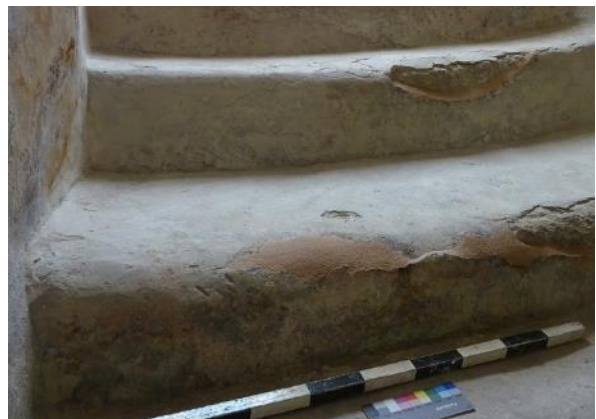
An orange repair mortar, based on NHL, was used as it was developed by Theo Schubert²⁷ (still wet on the picture):

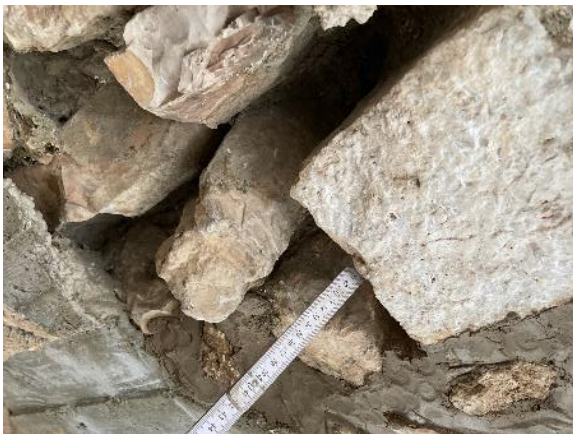
The loose mortar in the ceiling of this Miqveh has been removed gently step by step. It came out, that the stones of the vault's construction have a conic shape. The stones are stably connected with each other. Therefore, a structural stability in the whole vault is given. After scratching out and cleaning the joints from 15 up to 30 centimeters, the refilling has been executed with similar material in accordance to the current ceiling construction. Because of the moisture in the baths especially during the winter months, the formulation of the mortar includes hydrated lime. This lime is especially suitable because of the water permeability; it doesn't block incoming moisture from above the vault but gives space to evaporate after entering and keeps structural stability at the same time. The concrete on the surface, originated from former repair measures and displaying marks from the formwork, remain unaffected. This work has been done by professional stone mason in consultancy with an engineer.

Figure 90: vault after scratching, E. Thierry, 2021

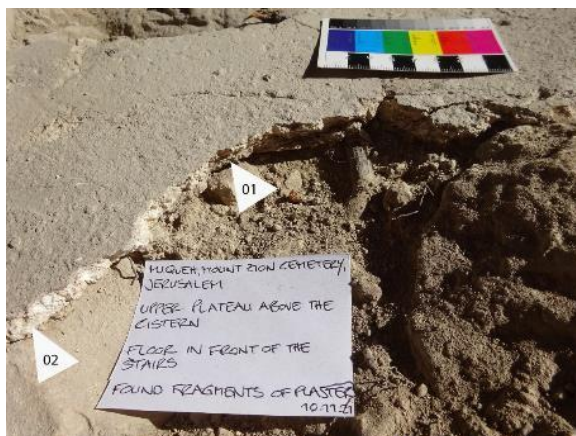
A fragment of plaster was found on the floor of the upper plateau, in front of the stairs. The plaster consists of two layers: the bottom layer is a beige/grey plaster with pieces of ceramic split. The upper layer of plaster is very bright and the surface has been smoothed.

Figure 106: Detail of the fragment of plaster with its two layers: 01 course layer, 02 upper layer

Before the execution of the new floor, it was necessary to preserve the fragment of plaster. The fragment has been in the ground for ages and to preserve it furthermore, the decision was made to cover it again with soil thus to restore it to its previous condition. The materials used to stabilize the plaster, before covering it with soil again, were made of the same soil, it was covered with in first place. The plaster was dry cleaned with a brush and afterwards were the edges stabilized with clay mortar. The cracks were filled with injection mortar based on clay and afterwards closed with the same clay mortar. In the end, the surface of the entire fragment was covered with clay plaster. The clay mortar is an entirely reversible treatment, but protects the fragment of plaster while building the new floor.

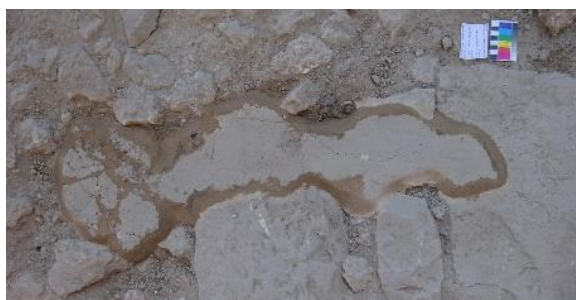
Figure 108: Condition after injections and pointing

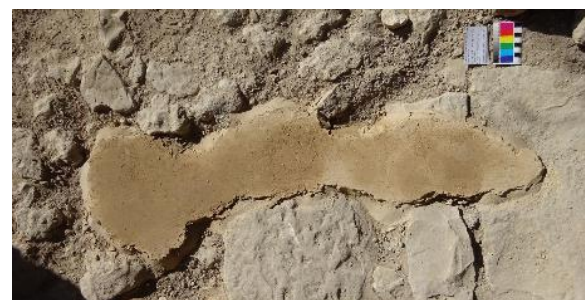
Figure 109: Condition after covering the fragment with clay plaster

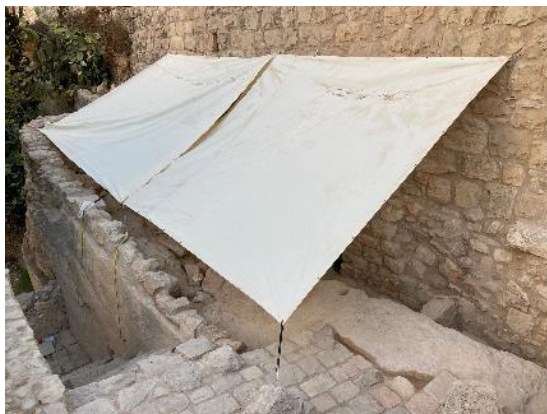
Figure 112: protective rain tarp, 2021

A permanent roof has been classified as unnecessary, because the inflow of rainwater can not be avoided relevantly. Besides that, a roof would disturb the architectural view of the building. Instead, a flexible horizontal coverage just in front of the baths entrances with waterproof material has been installed for the duration of the winter months. The tarp is removable and has been installed with a minimum of damage in the original substance of the walls.

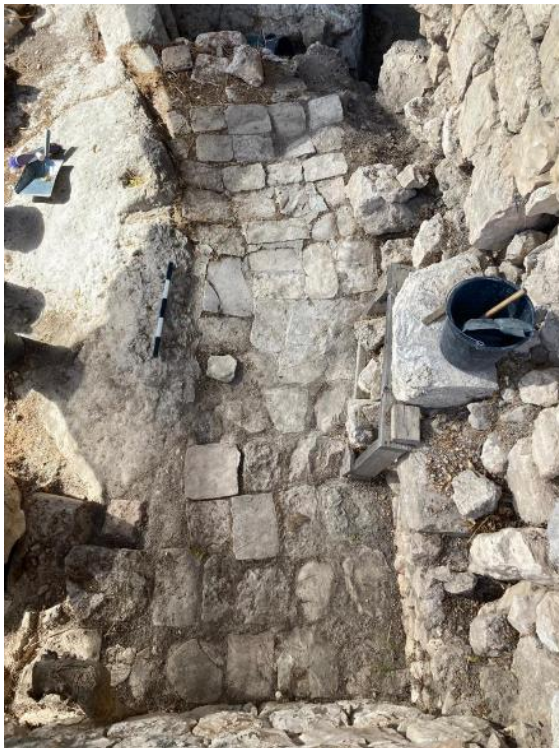
In the southeastern front of the cemetery wall the floor tiles and substructure has been removed to gain access to the bottom parts of the wall. Therefore, soil has been removed up to -80cm, until a rock hewn structure has been discovered. There have been found traces of ancient mason tools as well as a rock hewn channel, a drainage towards the cistern and a basin overflow. Because of the traces of the mason tools, there is a presumption that the discovered structure belongs to the most ancient parts of the Mikveh complex. The complete explanation of the traces is summarized in an attachment to the report in german language.³⁰

Figure 114: rock hewn structure, in some parts covered with soil and tiles (before measures)

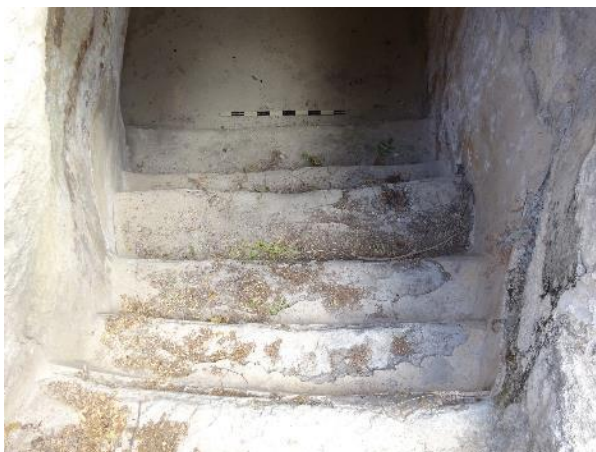
Figure 130: Previous condition of the steps in miqveh 2, 2021

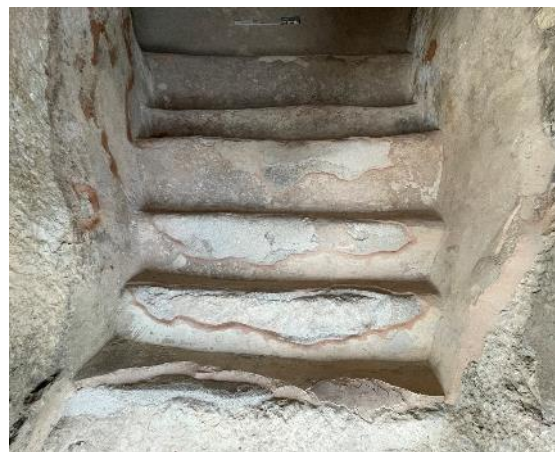
Figure 131: Condition of the stairs after restoration, 2022

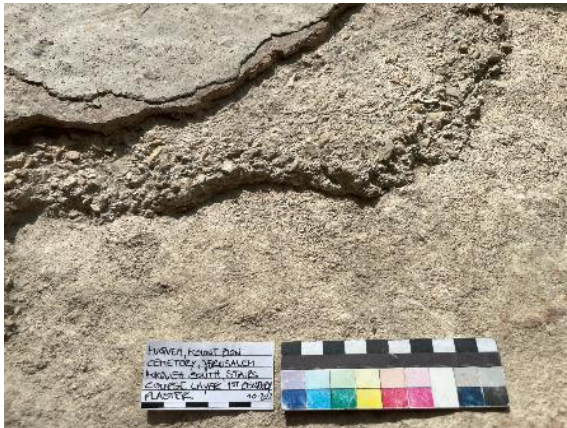
Figure 132: Erosion of the 1st century plaster layer

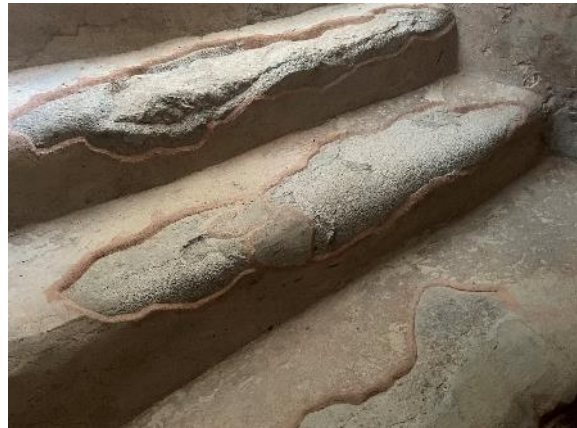
Figure 133: Filled gaps of the 1st century layer by means of a grey repairing mortar and pointing of the orange mortar
